Thomas F. Newkirk
1316 Royal Ave., NE
Canton, OH 44705
November 9, 1997

OHIO CAST PRODUCTS ("OCP")
15 76 05 0200
INSPECTION REPORT
OCTOBER 3, 1997

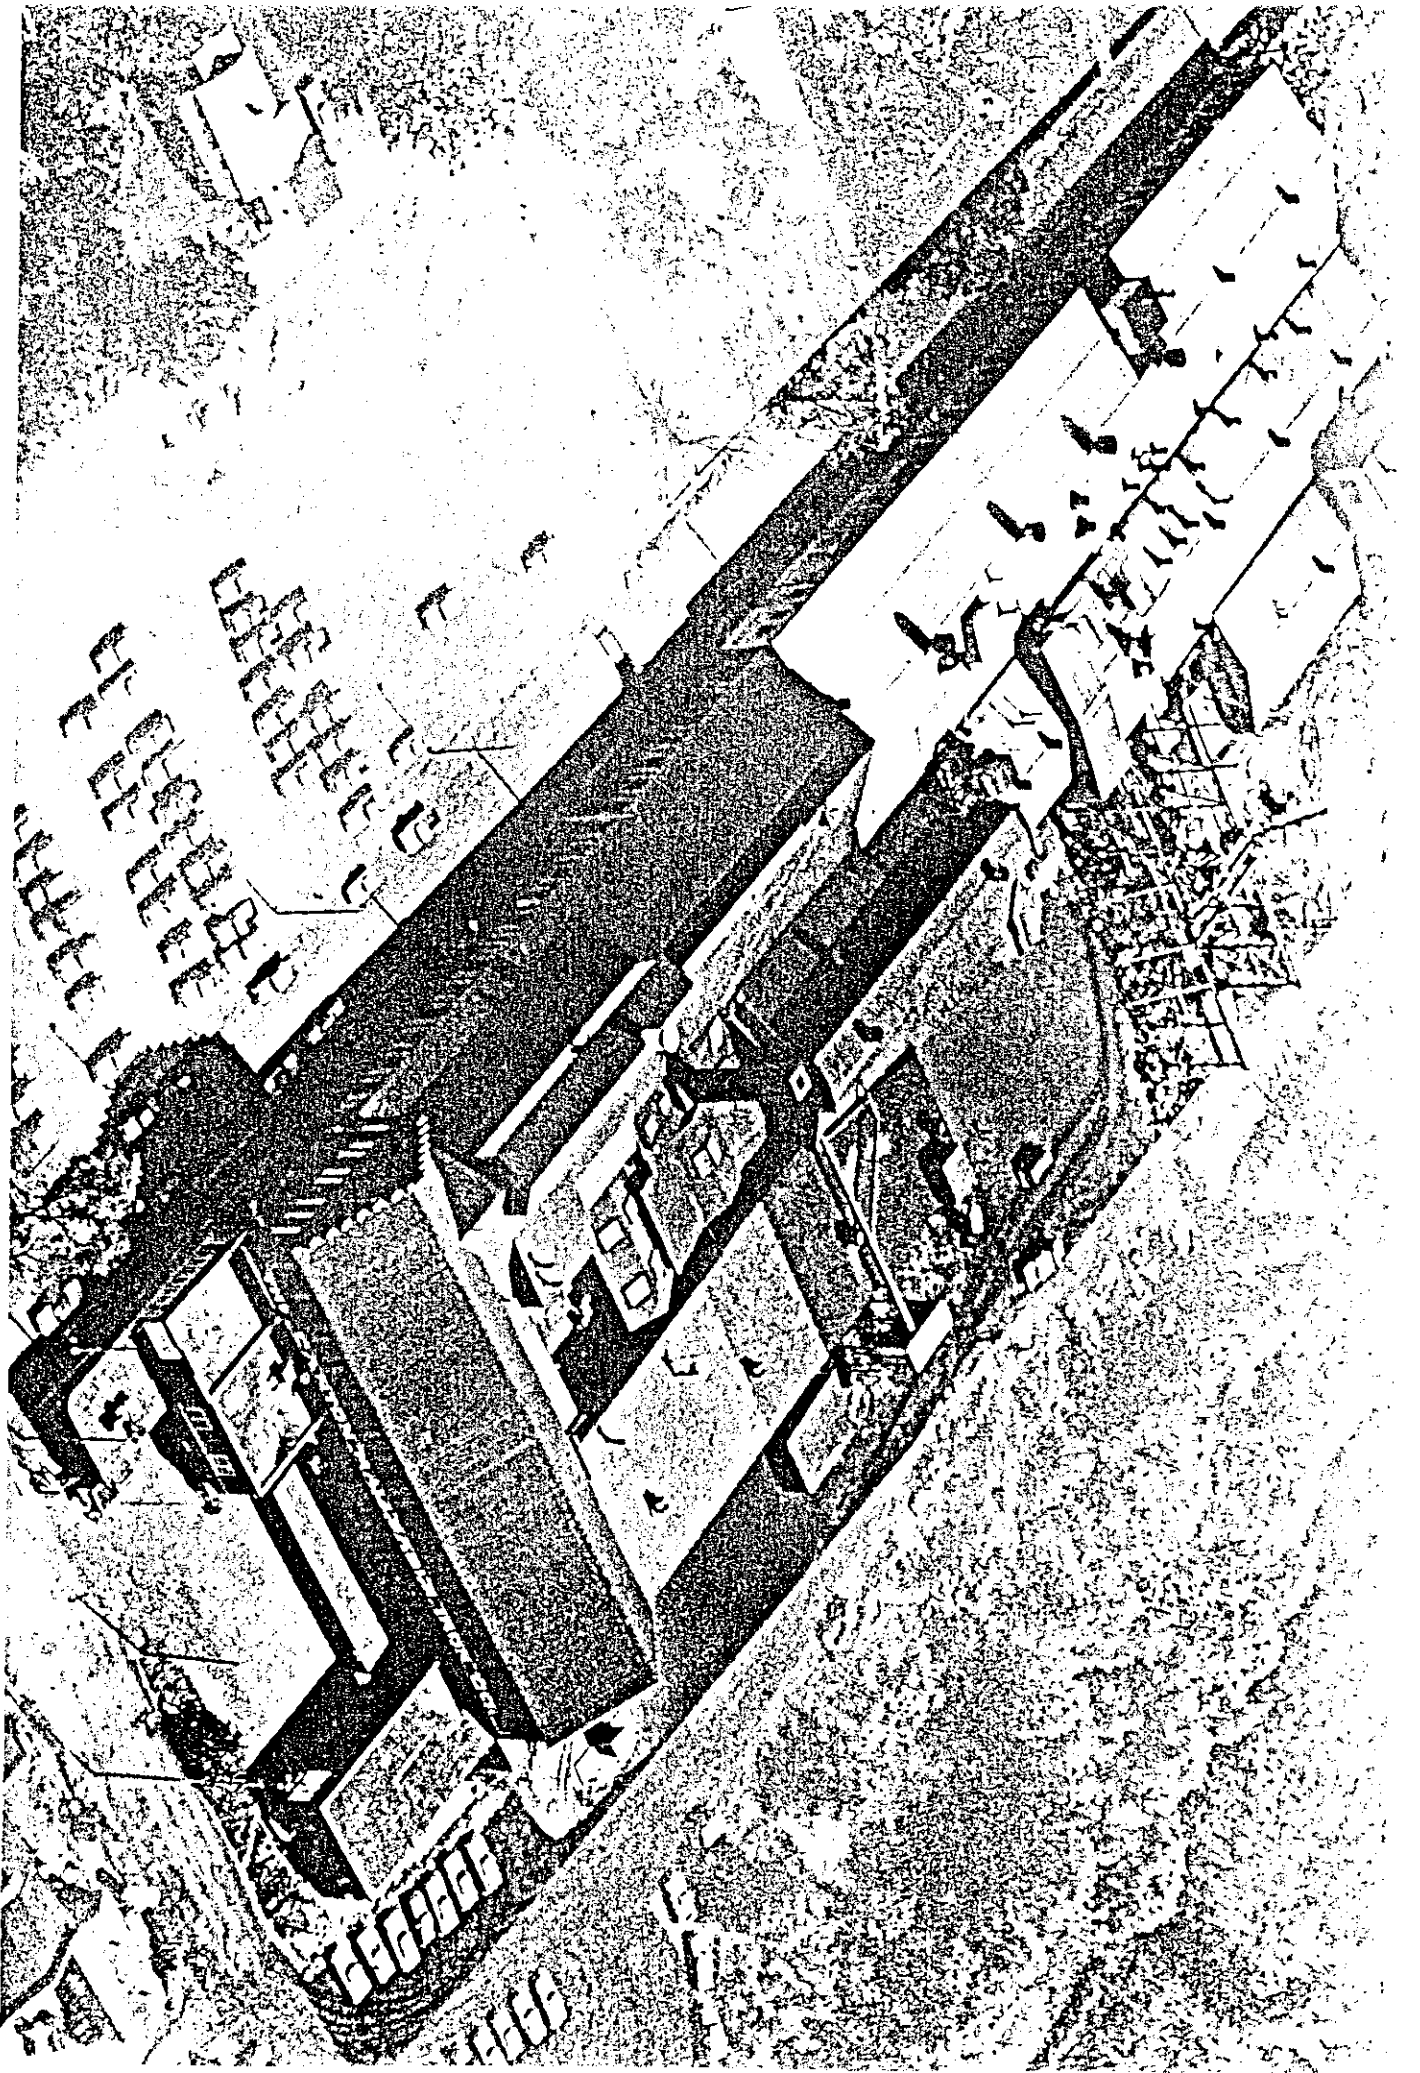
Canton Malleable Iron Company's
126,000 sq. ft. plant in Canton, Ohio.
